RESEARCH MEMORANDUM

EXPERIMENTAL INVESTIGATION OF AIR-COOLED TURBINE BLADES
IN TURBOJET ENGINE

XIII - ENDURANCE EVALUATION OF SEVERAL PROTECTIVE
COATINGS APPLIED TO TURBINE BLADES OF
NONSTRATEGIC STEELS

NACA RM E53E18

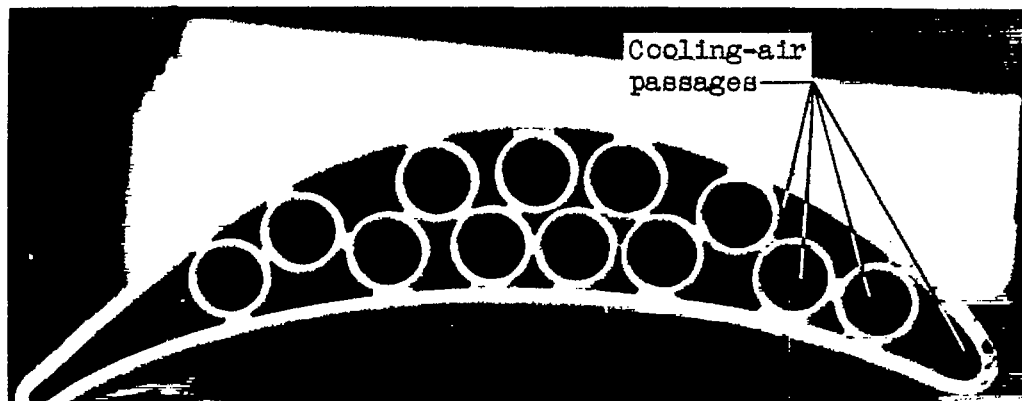
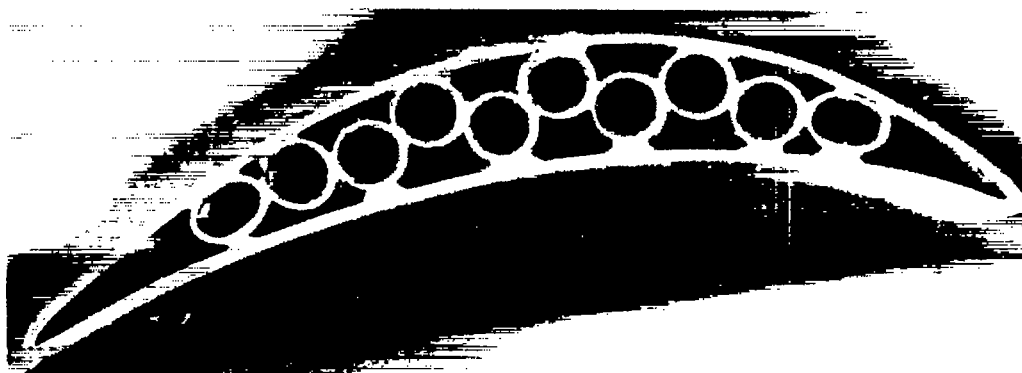
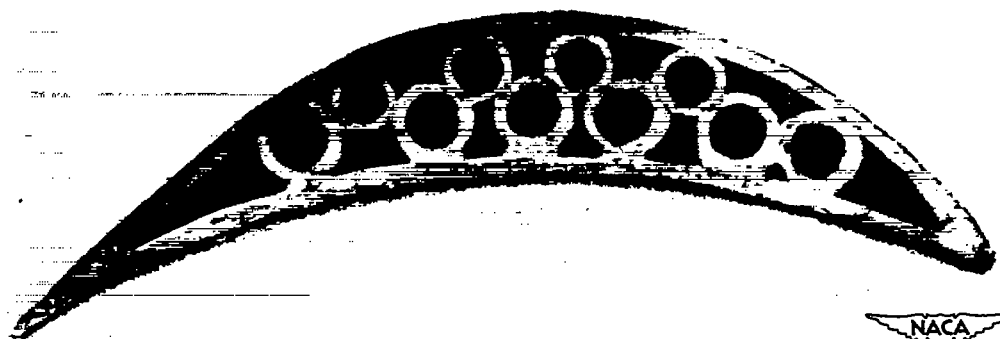
Figure 1. - Cross sections of experimental blades.

The internal heat-transfer areas of all blades were increased by brazing mild steel tubes to the inner surfaces of the shells, as shown in figure 1. Copper was used as a braze material for all blades except numbers 26 through 29; Nicrobraz was substituted in these blades because copper would be attacked by molten aluminum during the aluminizing process.

The three blade profiles used in this investigation are shown in figure 1. The root profiles are the same as the tip, except for a slight change in the outside contour because of the tapered wall of the shell. Profiles A and B (figs. 1(a) and 1(b), respectively) were obtained by forming the shells, and profile C (fig. 1(c)) was obtained by casting. Profiles A and C are essentially the same and are nearly equivalent to the root profile of the standard uncooled turbine blade used in the test engine. Profile B was an airfoil section which was designed to operate in a completely air-cooled turbine rotor with twisted stator blades. Table II indicates the profile of each blade. The various blades used were selected because they were readily available from other investigations and thereby reduced the time required to prepare for the coating investigation.

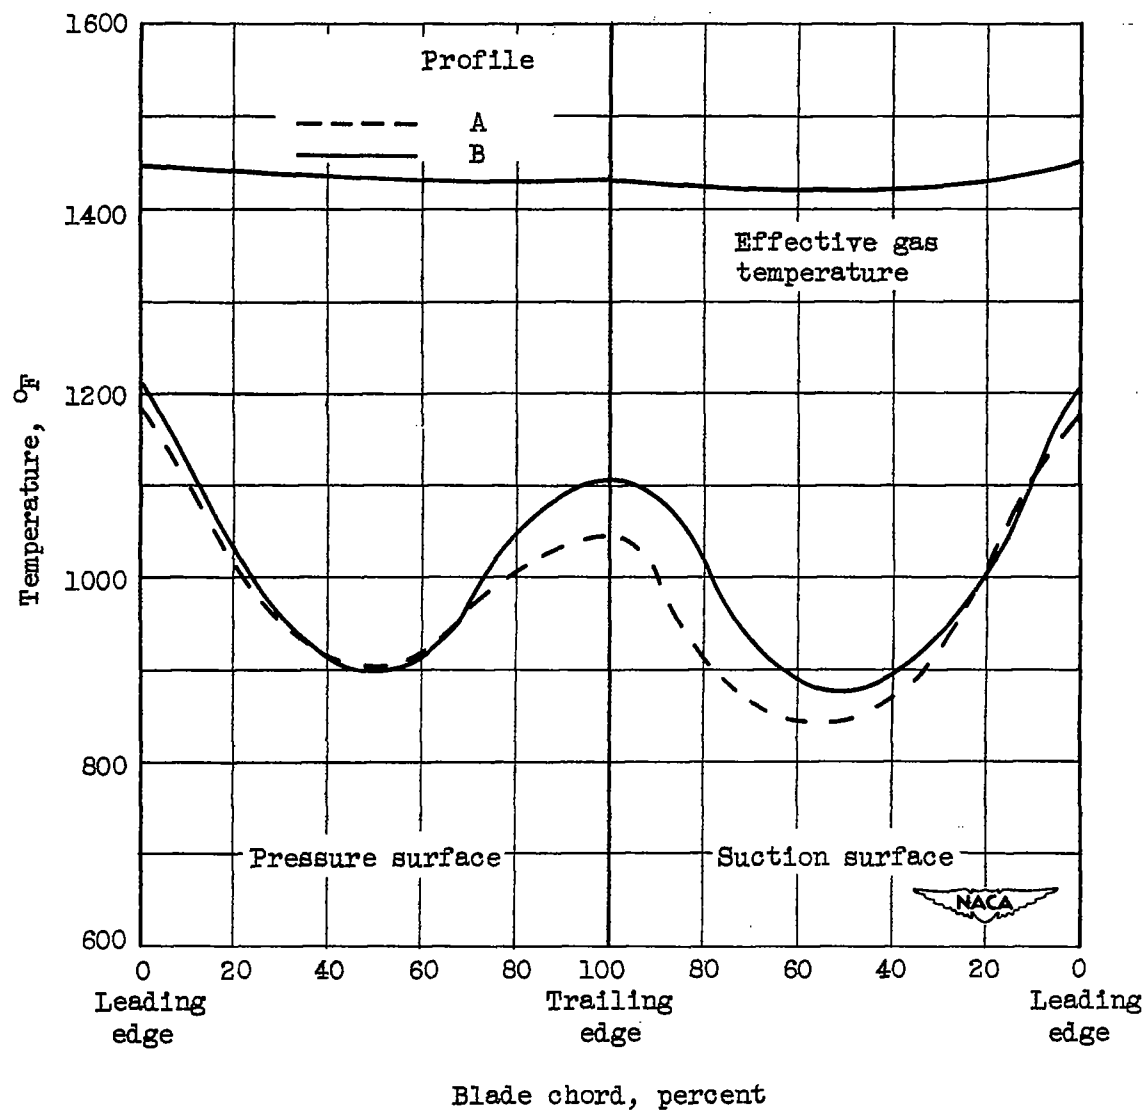
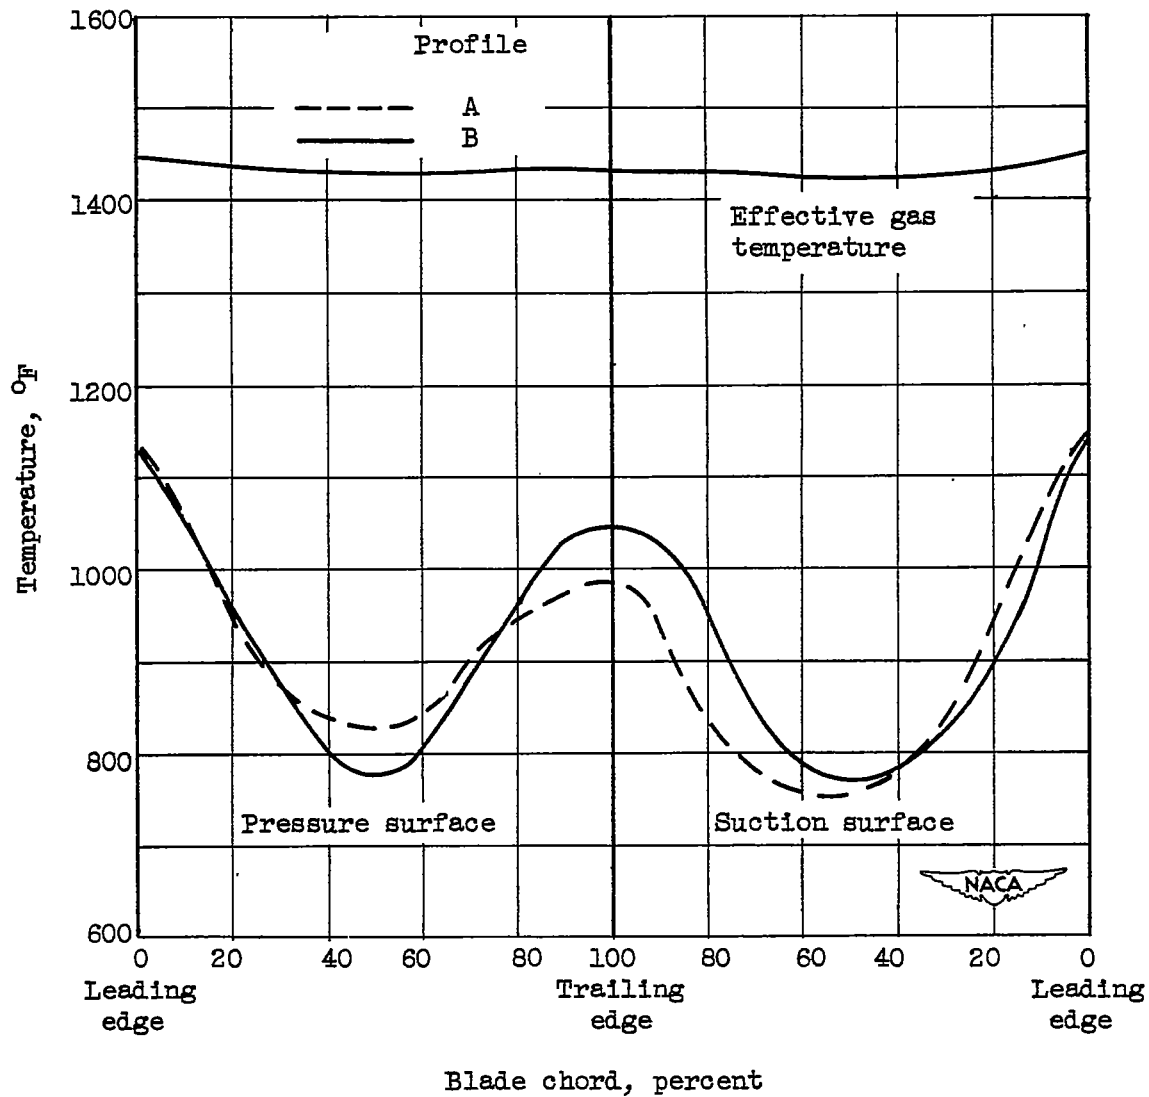
Figure 2. - Peripheral temperature distribution at section $2\frac{9}{16}$ inches from tip for blades of profiles A and B.

Although the metal shell of an air-cooled turbine blade is considerably cooler than the combustion gas, the temperature level is still relatively high. Experimental chordwise temperature distributions in the shells of air-cooled turbine blades of profiles A and B (see fig. 1) for coolant-flow ratios of 0.05 and 0.03 are shown in figure 2. Although these temperature distributions were obtained for specific air-cooled blades operating in a particular turbojet engine, they are indicative of the temperature levels at which metals and coatings for forced-convection air-cooled turbine blades might operate in present-day turbojet engines. It may be seen that leading and trailing edges operate at temperatures as high as 1200° F, while the midchord regions are 200° to 300° F cooler.

The blade temperatures shown in figure 2 for profile B are somewhat higher than those reported in reference 9 for the same profile. The values of figure 2 are based on more comprehensive experimental data.

the blade where the coating flaked off. The failure of the coating apparently was a function of the metal temperature, as the greatest damage to the coating occurred at the leading- and trailing-edge regions where the metal temperatures are the highest (see fig. 2). More coating was removed from the leading edge than from the trailing edge, probably because the high-velocity combustion gases impinge directly upon the leading edge and their erosive action is greatest in this area.
